⑥ National Dam Inspection Program, Gunter Valley Dam (Inventory Number NDS-PA-323), Susquehanna River Basin, Trout Run, Franklin County, Pennsylvania. Phase I Inspection Report.

GUNTER VALLEY DAM

INVENTORY NUMBER NDS PA-323

PHASE I INSPECTION REPORT

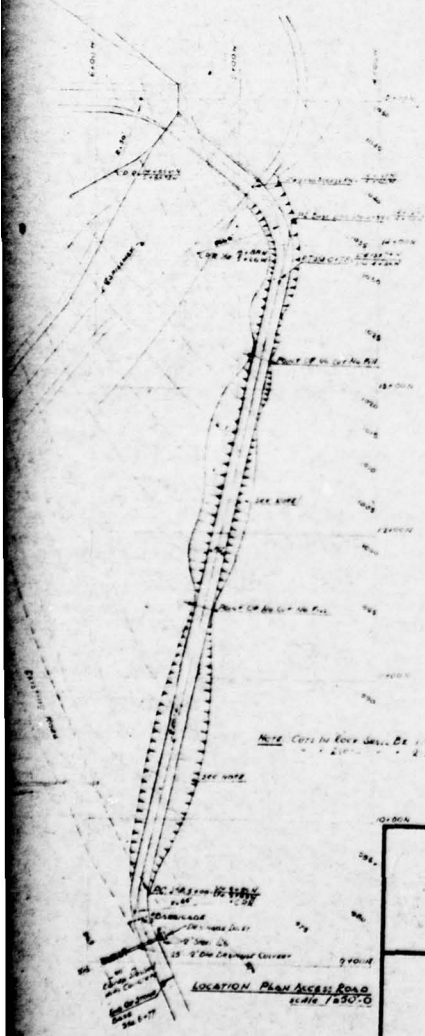
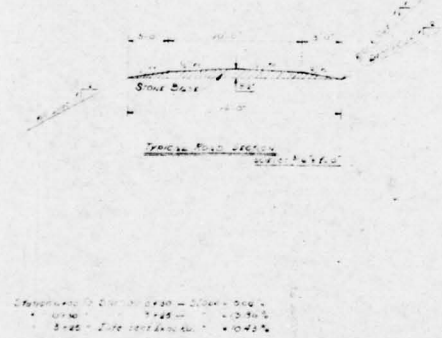
PLATE IX

of dam through the overburden to "solid bedrock". The profile of the dam (Plate IX, Appendix D) indicates that a 60 feet deep grout curtain was to be used over the full length of the dam and spillway weir. A 2-foot thick dumped rock riprap is shown on the upstream slope. A safety factor of 1.6 was found for sudden drawdown condition on the upstream slope. A slope stability analysis for the downstream slope indicates a factor of safety of 1.9 under steady seepage condition. Cutoff walls were provided where the embankment meets the spillway wall.
